BELZONA[®]
GREAT LAKES

**LOCAL GOVERNEMENT
PIPE
RESTRENGTHENING**

WATER PIPE
NOVEMBER, 2020

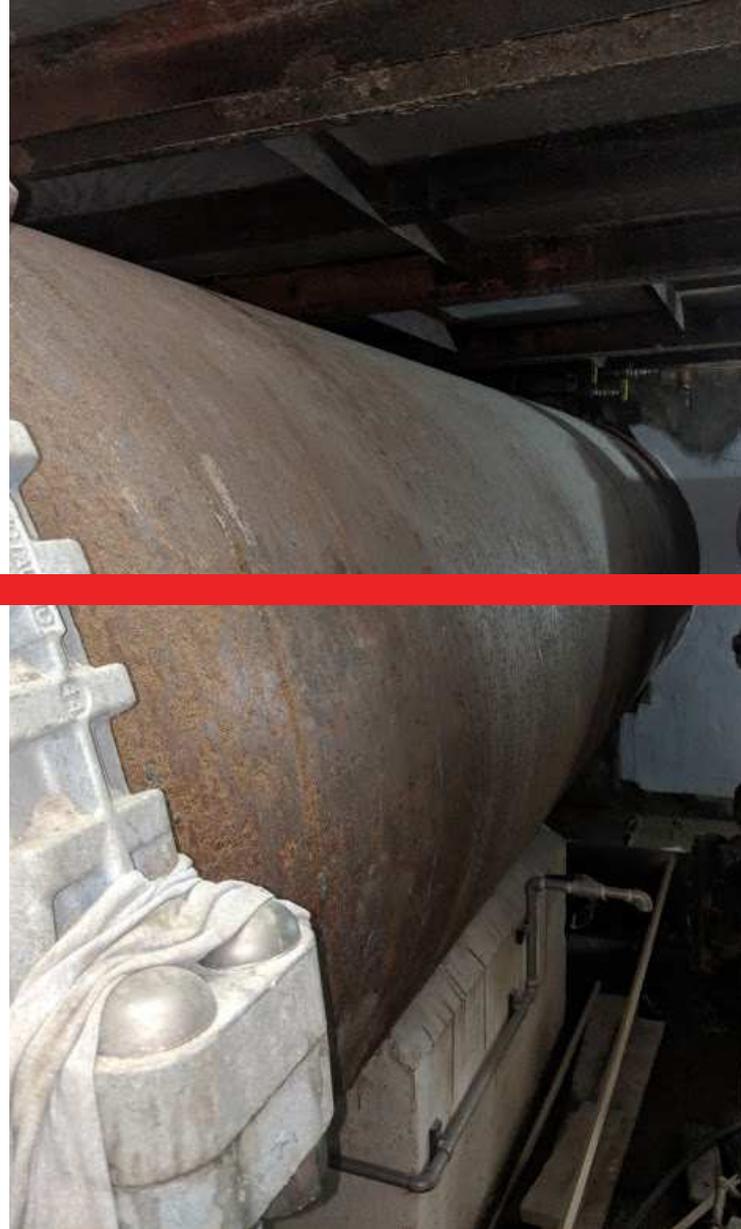
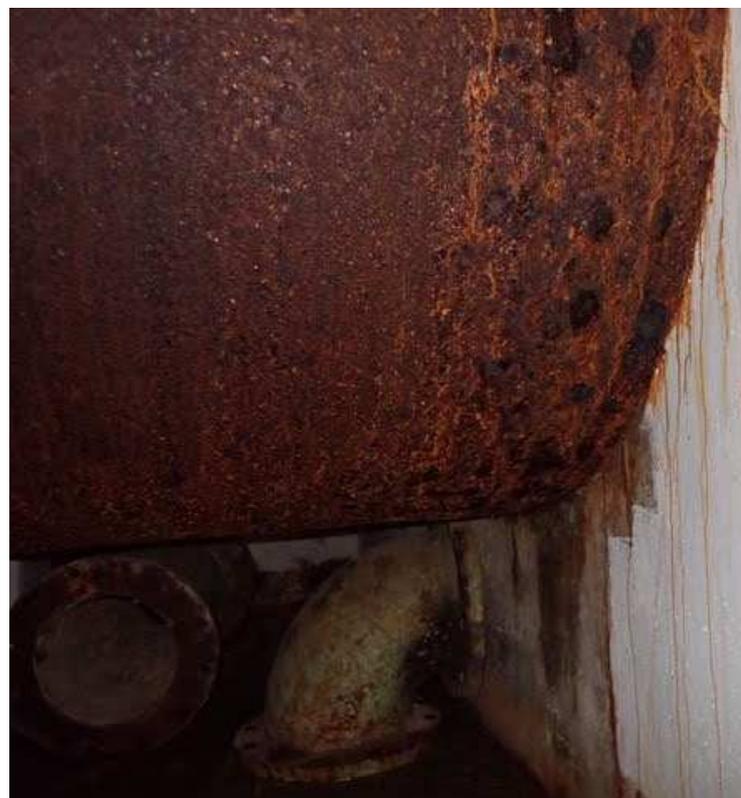
One of the assets they needed to repair was a 60" carbon steel pipe that had suffered from external corrosion and metal loss over the years. The defective area was about 15 feet. They required a solution that would reinstate the structural integrity of the pipe.

Belzona Great Lakes calculated the number of wraps required using ASME PCC2 equations. The defect was type A (thin wall), corrosion was external, and the pressure was relatively low (25 psi). 2 wraps of Belzona SWII were recommended to structurally reinforce the pipe and effectively stop corrosion on the pipe. This repair system can remain maintenance-free for up to 20 years.

First, the pipe was grit blasted and prepared according to SSPC SP10. All the pitting and resurfacing was then done with Belzona 1121 (Super XL-Metal) because of its longer overcoating time. The next day, they started applying Belzona SWII. They applied the wrap in 4 feet sections at a time, so every 4 feet they would consolidate the repair with Belzona 9382 and continue with the next section. Though the application was during colder climate, Belzona 1982 was chosen to give more working life and allow the crew to complete the application properly.
